LIGHTNING STRIKE TESTING RESULTS ON HONEYCOMB PANELS PROTECTED WITH A SERIES OF DEXMET MICROGRID® PRODUCTS

This paper, [which has been abridged from the original](#)¹, explores the comparative results of performing lightning strike damage testing on a series of thin skinned honeycomb panels using protective metal mesh materials. Damage assessments were performed using ultrasonic and visual non-destructive inspection methods.

Lightning Strike Protection for Carbon Fiber Aircraft

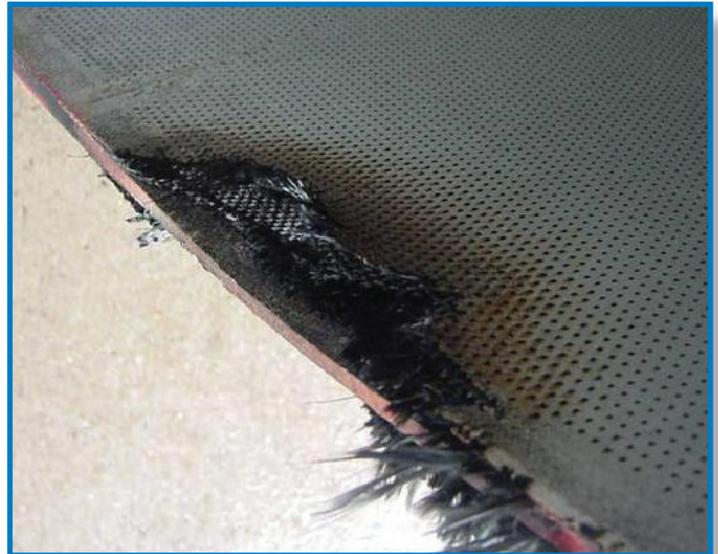
Figure 1: A generic thrust reverser panel with lightning strike damage

An aircraft is divided into zones of severity of potential lightning strike damage. The two most severe categories of zoned lightning strike damage for nacelle products are Zone 1A and Zone 1B requirements, per SAE ARP5414. An example of the types of damage being witnessed on shorter mission commercial airplane nacelle products is shown in Figure 1. This particular structure did not have protective materials in its configuration.

To emulate the damage shown in Figure 1, testing on a variety of honeycomb panels was performed using Zone 1A and 1B criteria. The individual components and values for Zone 1A and Zone 1B are shown in Figure 2, and are defined in SAE ARP5412

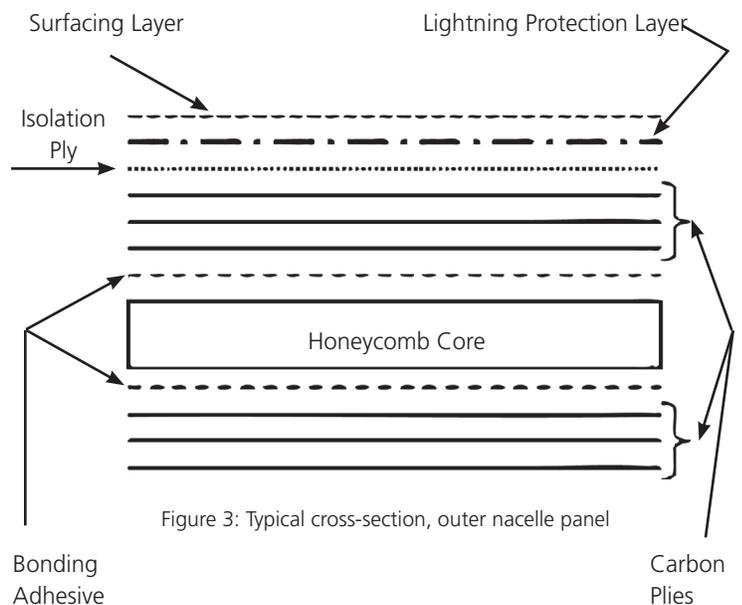
Figure 3: Typical cross-section, outer nacelle panel

The representative coupons on which lightning strike testing would be performed had to emulate the laminate, core, adhesive, and protective mesh configurations common to nacelle panels subject to lightning strike. Figure 3 illustrates a standard cross-section for nacelle panels subject to lightning strike events.

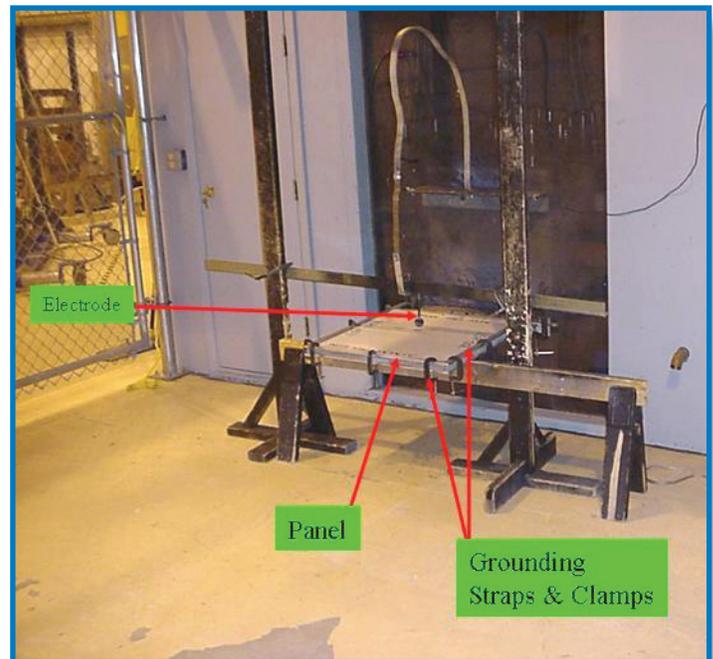
Figure 5: lightning strike test set-up with panels in place

Each of the 60.96cm (24 inch by 24 inch) square coupons was placed beneath an electrode, such that the Zone 1A or Zone 1B emulated strike would be at the center of the panel. Grounding straps held the panel in place at all four edges of each coupon. The coupons were also configured, during the construction, with a layer of aluminum tape closing out the edges of the panel, between 3cm and 5cm (1.5 to 2 inches) wide. This provision of aluminum tape was for better ground strap engagement. Figure 5 illustrates the test set-up.

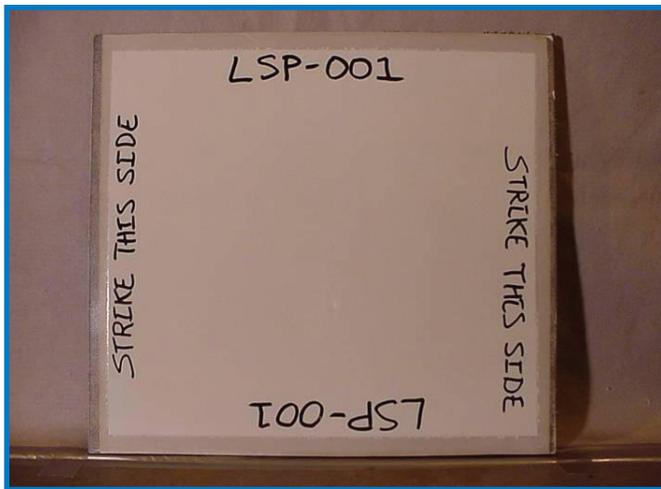
Figure 6: LSP-001 prior to lightning strike test

Each of the 60.96cm (24 inch by 24 inch) square coupons was struck in accordance with Figure 2. Results from the testing included visual examination of the exterior damage, and non-destructive inspection using primarily thru-transmission ultrasonic (TTU) methods. For the following sections comparing different parameters of panel configuration, both Zone 1A and Zone 1B effects are shown. Figure 6 illustrates a typical panel prior to testing.

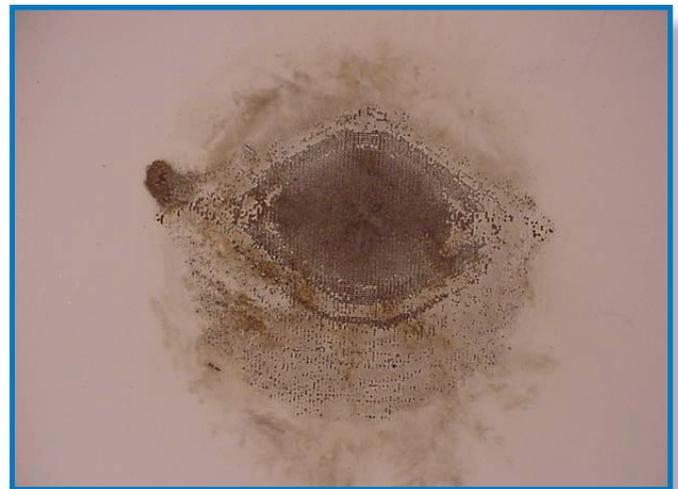
Figure 8: LSP-001 close-up view

To further illustrate the effect of the lightning strike, Figure 8, provides a close-up view of LSP-001 after the emulated strike event. The aluminum mesh can be observed in the close-up view of LSP-001. Now compare, the unprotected panel LSP-026, and the subsequent damage in Figure 9. The strike event penetrated through LSP-026 panel, damaging the core by burning and puncturing both facings of a 25mm (1 inch) thick panel. The difference in damage resistance between a protected and unprotected panel is dramatic.

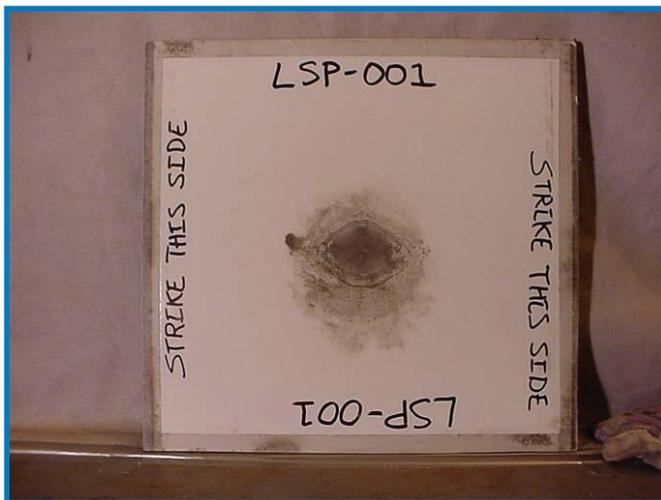
Figure 7: LSP-001 immediately after lightning strike test

Figure 7 illustrates the exact same panel immediately after the emulated strike. Damage was to the outer layer of surfacing adhesive as it burned away during the event, the metal mesh was still in tact; however it was disbonded from the isolation ply. For LSP-001, the substrate carbon/epoxy plies, were still attached to the core, and in serviceable condition. No penetration of the panel was observed.

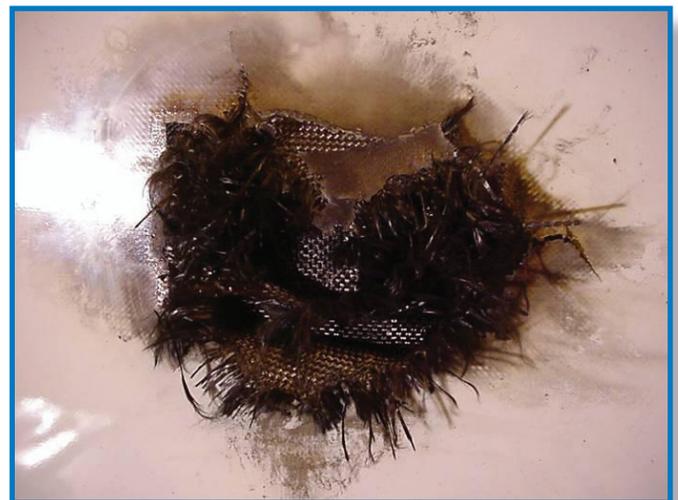
Figure 9: LSP-026 close-up view, identical to LSP-001 except no protection

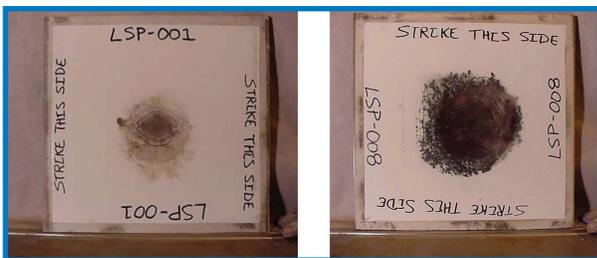
Figure 10: LSP-001 with aluminum mesh compared to LSP-008 with copper mesh

A group of panels from the test matrix were constructed to evaluate how different protective metal mesh products perform relative to each other when comparing equivalent weights and thicknesses of Dexmet expanded copper, Dexmet expanded aluminum, and phos-bronze interwoven wire. Figure 10 compares aluminum mesh and copper mesh on identical core reinforced panels.

The damage periphery with the copper mesh on LSP-008 is larger, measuring between 17-18cm (8 to 9 inches) in diameter. The aluminum mesh "diamond" shaped burn area from this Zone 1A emulated strike is 7-8cm (3 to 3.5 inches) at the widest points.

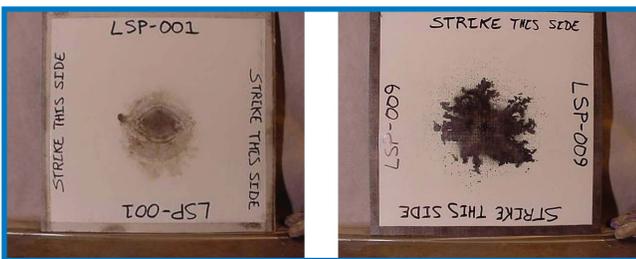
Figure 11: LSP-001 with aluminum mesh compared to LSP-009 phos-bronze IWWF

Figure 11 compares the Dexmet aluminum mesh and phos-bronze interwoven wire on identical core reinforced panels.

The damage periphery with the phos-bronze IWWF on LSP-009 is obviously larger, measuring between 14-15cm (5 to 6 inches) in an approximate diameter. The Dexmet aluminum mesh "diamond" shaped burn area from this Zone 1A emulated strike is 7-8cm (3 to 3.5 inches) at the widest points. The phos-bronze panel had less damage to the surface area than the copper mesh panel, however, the phos-bronze panel (LSP-009) exhibited a multitude of ruptures of the interwoven wire throughout the surface area of the panel. The phenomenon of interwoven wire rupturing in a multitude of locations during a Zone 1A lightning strike event, may influence the decision of how much total surface area damage requires repair.

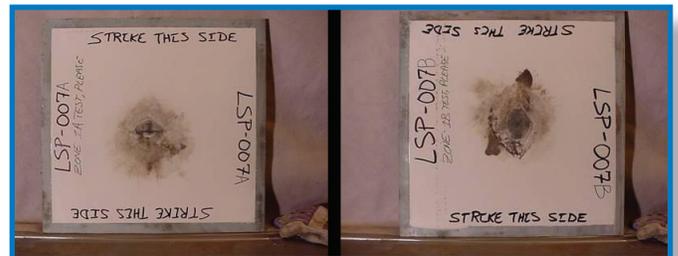
Figure 20: LSP-007A (Zone 1A) and LSP-007B (Zone1B)

The lightning strike testing characterized both Zone 1A and Zone 1B testing and the effect it would have on the individual panels. The primary concern for honeycomb panels in this application was Zone 1A damage tolerance, however, Zone 1B was characterized to show the difference in the response of the panels tested. The primary difference between Zone 1A and Zone 1B is the charge transfer of the "C component" and the existence in Zone 1B of a "D component". Reference Figure 2 for further detail. Two sets of panels were duplicated to perform identical Zone 1A and Zone 1B testing for comparative analysis. LSP-007A and LSP-007B for 3mm cell core and LSP-016A and LSP-016B for 9mm cell core were subjected to Zone 1A and Zone 1B testing. Figure 20 shows the side-by-side differences between realized damage from a Zone 1A event and Zone 1B event on a 25mm thick honeycomb panel with aluminum mesh protection. The Zone 1A damage is on the left, the Zone 1B damage is on the right.

The Zone 1B damage periphery is greater than the Zone 1A damage periphery. This was an expected result due to the higher energy transferred and longer duration of the charge transfer for a Zone 1B event. Although the damage area was increased, (11-12cm for Zone 1B versus 79cm for Zone 1A) the damage depth was almost equivalent with some damage to the fiberglass isolation ply, though no disbonding from the substrate carbon plies was observed. The substrate carbon plies and core-to-adhesive bond was maintained and undamaged. Figure 21 shows Zone 1A and Zone 1B damage for 9mm cell core.

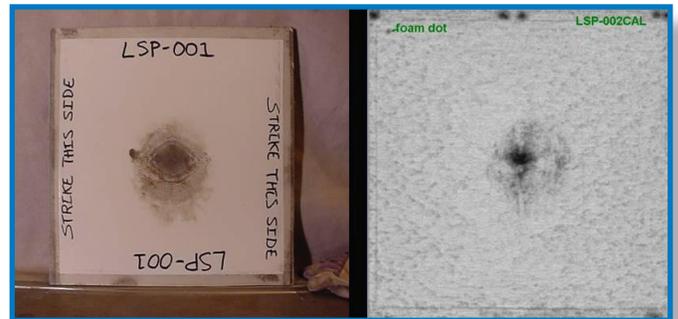
Figure 23: NDI via TTU of LSP-001 (NDI to the right)

The purpose of performing NDI on each of the lightning strike test panels is to validate the damage periphery and depth of penetration of the lightning strike emulated event. Additionally, an understanding of the NDI “signature” can be developed for a known set of configurations, when struck by a simulated lightning strike event. Figure 23 shows LSP-001 on the left and the NDI scan of LSP-001 on the right. This panel was a 3 mm cell core, with aluminum mesh, and S-2 isolation ply for galvanic protection.

When evaluating Figure 23, a noticeable characteristic begins to evolve for this panel since the NDI pattern of damage is actually smaller than the visually obvious area of burned away surfacing film. Follow on destructive investigation confirmed that damage was limited to just the surfacing film and the aluminum mesh protection. Figure 24 illustrates an NDI signature for an unprotected panel represented by LSP-026.

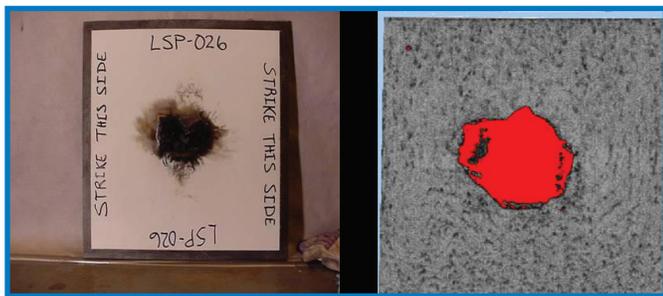
Figure 24: NDI via TTU of LSP-026 (NDI to the right)

The LSP-026 was identical to LSP-001, except with no metal mesh protection. The damage on the LSP-026 punctured panel is slightly larger than what is obvious from visual inspection. This panel was damaged all the way through both facings and core. Additionally, from the NDI scan, the damage extended another 2-3cm around the visual damage periphery. Figure 25 illustrates an NDI signature for a Dexmet metal mesh protected panel, using 9mm cell core, represented by LSP-011.

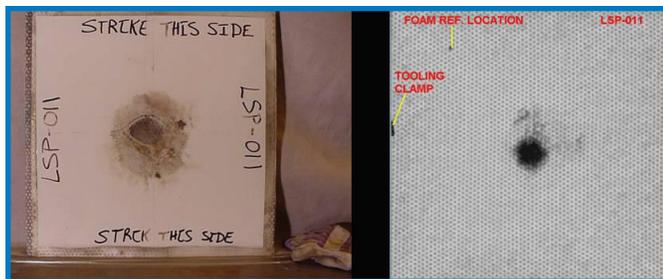
Figure 25: NDI via TTU of LSP-011 (NDI to the right)

The NDI scan on the right, of LSP-011 reveals slightly less perimeter damage than the visual burning evident on the panel. Damage penetration was limited to surfacing material burned away, and the metal mesh being delaminated. The isolation ply material and substrate carbon plies remained undamaged. Figure 26 shows an NDI scan of an unprotected panel identical to LSP-011, except no metal mesh exists on LSP-027.

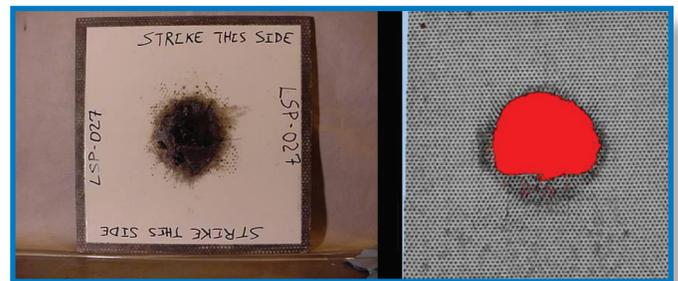
Figure 26: NDI via TTU of LSP-027 (NDI to the right)

NDI scan for LSP-027 is a little larger than the visually observed damage. LSP-027 suffered through penetration damage of both facings due to the lightning strike event. The NDI signature for this panel confirms this damage with very high attenuation.

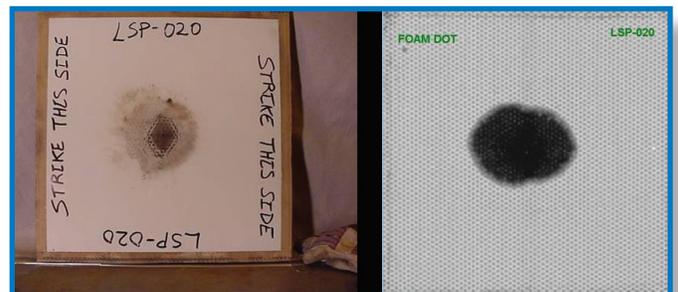
Figure 27: NDI via TTU of LSP-011 (NDI to the right)

Figure 27 shows the NDI scan of an aluminum metal mesh protected, aluminum honeycomb core panel subjected to lightning strike Zone 1A testing.

In this instance, the NDI scan reveals larger damage than the visual damage periphery on the left. This effect is different than the trend for non-metallic core reinforced panels such as LSP-001 and LSP-011. This larger damage area is attributed to the nature of how an aluminum core panel will react to a lightning strike event, even when protected. Additionally, all plies were delaminated away from the core, which is also

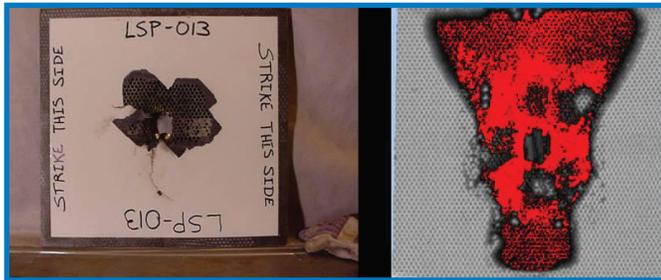
Figure 28: NDI via TTU of LSP-013 (NDI to the right)

different than prior non-metallic panel damage resistance to a Zone 1A lightning strike event. In stark contrast, Figure 28 shows the NDI scan for an un-protected, aluminum core panel.

The NDI scan for LSP-013 reveals that the damage is far worse than the visual observation. From the NDI scan for LSP-013, it can be seen that the panel is ruptured across the entire width, and completely unable to withstand any type of loading. Both facings were delaminated and broken in the area of high attenuation highlighted by the NDI scan.

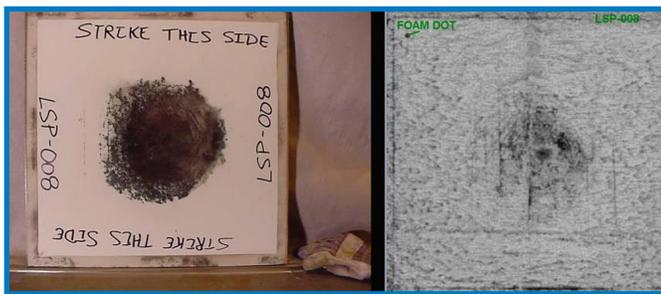
Figure 29: NDI via TTU of LSP-008 (NDI to the right)

Figure 29 shows the NDI scan of a 3mm cell core panel, 25mm thick, using aramid fiber core, and protected with Dexmet copper mesh.

The NDI scan for LSP-008 is consistent with the damage exhibited from prior non-metallic core panels. The substrate carbon plies remain attached to the core, and only the copper mesh was delaminated away from the substrate at locations indicated by the attenuation (darker areas). The area of damage is larger for the copper mesh than for the aluminum mesh of prior panels. Both the copper mesh and aluminum mesh in this test were the same area weight.

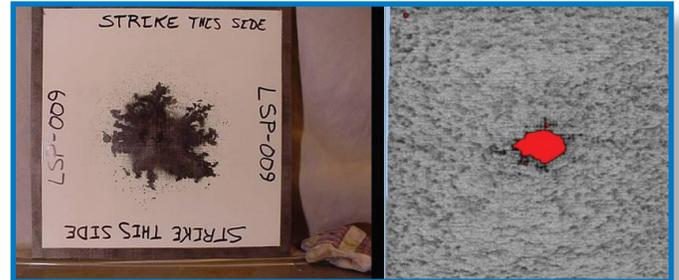
Figure 30: NDI via TTU of LSP-008 (NDI to the right)

Figure 30 shows the comparative NDI scan for LSP-009, which is an aramid fiber core, 3mm cell, 25mm thick panel using phos-bronze interwoven wire as protection.

The NDI scan reveals an area of disbond smaller than the visually obvious burned area on the left. Additionally, the scan reveals that with the phos-bronze IWWF, a greater depth of penetration occurred for substrate plies, though not completely delaminating from the substrate core. In contrast, where Dexmet copper mesh and Dexmet aluminum mesh protected all the substrate plies, the phos-bronze IWWF allowed a level of penetration into substrate plies that was not evident on the other configurations. Figure 31 shows an NDI scan of 3mm cell aramid core, 12.5mm thick, with aluminum metal mesh protection. This panel was tested to reveal any differences in lightning strike damage resistance on a panel thinner than 25mm.

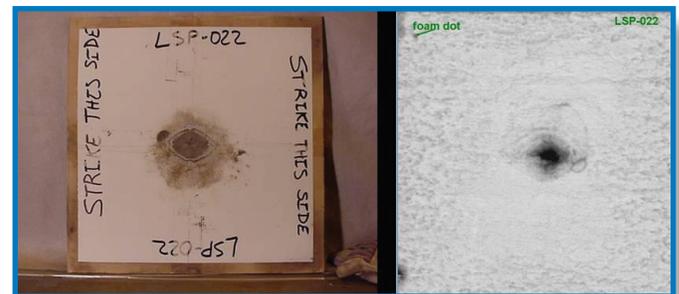
Figure 31: NDI via TTU of LSP-022 (NDI to the right)

The NDI scan revealed that the damage area was smaller than what visually burned away of the surfacing film. It was also noted, that the NDI scan for LSP-022 had more attenuation (darker areas) than the NDI scan for LSP-001, which is identical to LSP-022, except 25mm thick instead of 12.5mm thick. The reason for this could be that a 25mm panel has more bending stiffness than the 12.5mm panel. The lightning strike event produces a pressure wave that stresses the core and facings while the electrical discharge is occurring. The combination of these events apparently has the ability to produce a deeper penetration into the substrate plies for a thinner 12.5mm panel. But, the penetration is only one additional carbon ply in depth. Results of panel thickness testing were the same for 3mm cell core and 9mm cell core.

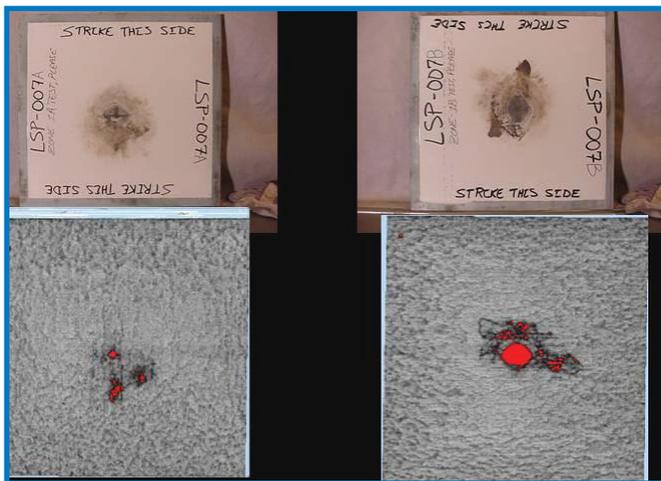
Figure 33: NDI via TTU of LSP-007A (Zone 1A) and LSP-007B (Zone 1B)

A final consideration was to observe the NDI results of panels struck to Zone 1A and Zone 1B criteria. Figure 3.2.2-1 shows the comparative NDI scans of panels LSP-007A and LSP-007B side by side.

The comparative NDI scans of the Zone 1A and Zone 1B damage show that the damage periphery is greater for Zone 1B, than for Zone 1A. It was also found that depth penetration into the fiberglass isolation ply was evident in places on the Zone 1B panel. The NDI confirmed the damage depth determine by the destructive testing. The "grey scale" on the NDI image was adjusted to further illustrate this finding.

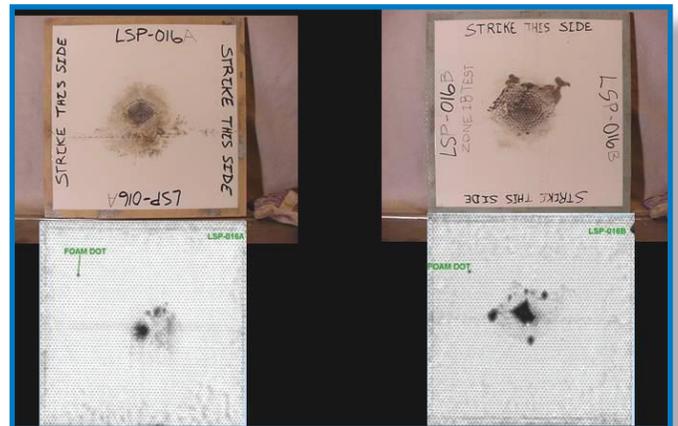
Figure 34: NDI via TTU of LSP-016A (Zone 1A) and LSP-016B (Zone 1B)

Figure 34 shows the comparative NDI scans of panels LSP-016A and LSP-016B side by side. These panels are identical to LSP-007 panels except they use 9mm cell fiberglass core.
